Minerals Inspection Report

Mine Name: Southwest #1	Permit Number: M/47/0103	Mine Status: Inactive
Operator Name: Red Leaf Resources	Inspection Date: 6/19/2018	Permit Fees: Paid
Inspector(s): A. Abate	Inspection Time: 9:00 AM	Bond Amount: \$3,776,000
Attendee(s): K. Johns, T. Waltman, J. Patten	Weather: Sunny 70s	Bond Escalation: 11/4/2015
Inspection Purpose: Annual Inspection		Prior Inspection: 5/24/2017

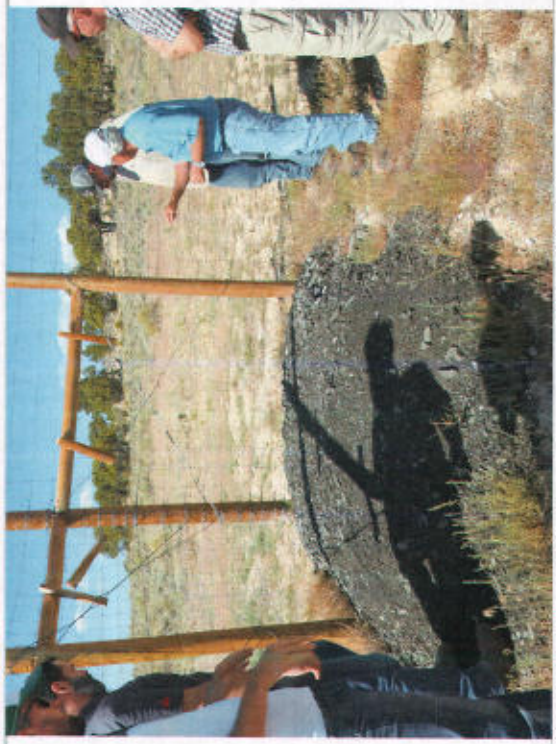
Mound of spent shale located in the reference area. This pile is being used as an experiment to see if the seed mix can grow on spent oil shale.

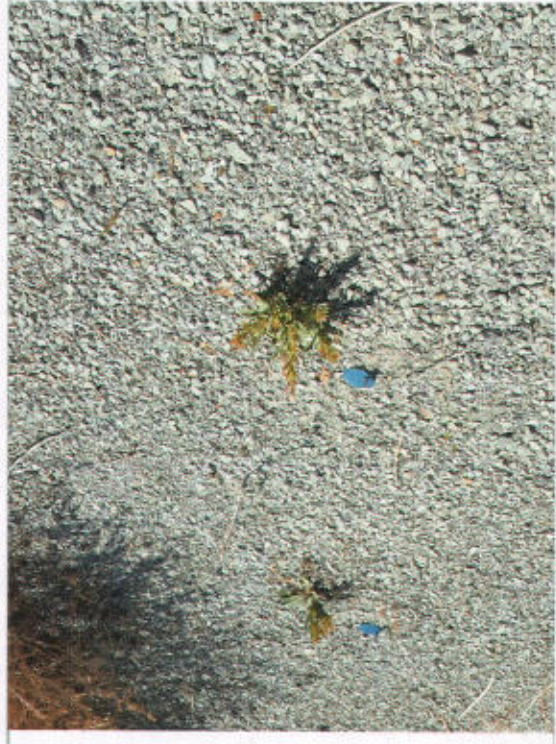
Penstemon is growing well on oil shale test plot.

Rare plant test area progress was discussed. Graham's Penstemon were growing in the test areas both on native soil and on crushed oil shale. The area that appears to be the most successful with the plantings is the test area is the oil shale outcrop with no topsoil cover. A new area of spent oil shale was added to the reference area to see if the approved seed mix could be planted successfully. Some seedlings were observed on the spent shale pile but not great likely due to lack of moisture. The Division provided the operator with the report that was issued by SWCA regarding the evaluation of the permit area for rare plants that are part of the *White River* Penstemon and Graham's Beardtongue Conservation Agreement.

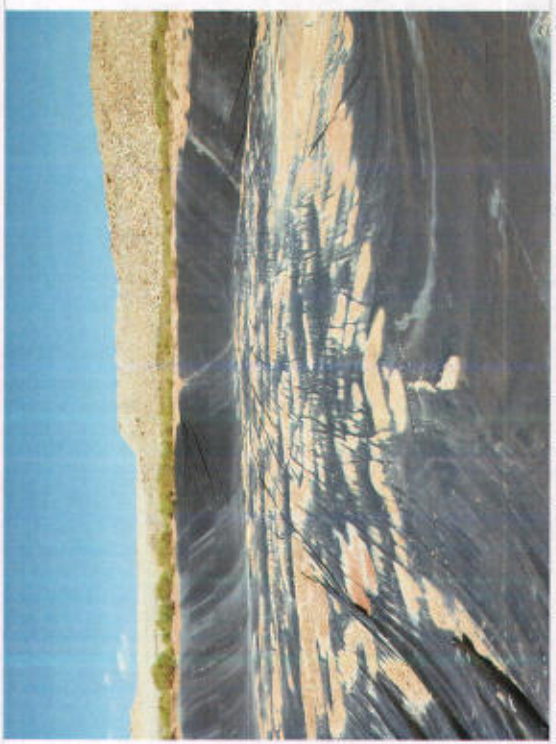
Construction impoundment was dry. Liner is not necessary in this pond if it contains well water or stormwater runoff only.

6. <i>Reclamation</i>	<input type="checkbox"/>	<input type="checkbox"/>
7. <i>Backfilling/Grading (trenches, pits, roads, highwalls, shafts)</i>	<input checked="" type="checkbox"/>	<input type="checkbox"/>
The exploration pit was recently partially backfilled in order to stabilize it. Discussed the need to line the construction pond which was just being used for dust control. The water when contained in it, is just well water or stormwater, so there is really no reason why it needs to be lined.

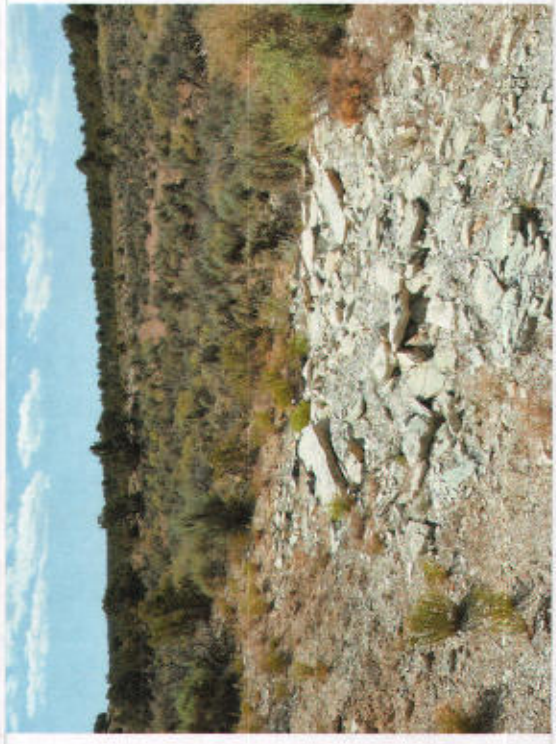
General vicinity of the seep located in the northeast portion of the permit area.

3. <i>Protection of Drainages/Erosion Control</i>	<input checked="" type="checkbox"/>	<input type="checkbox"/>
Detention sumps are located throughout the permit area around its perimeter. Sumps are cleaned out on an as-needed basis. Inspected a nearby seep in the northeast corner of the permit area. The seep was not flowing at the time of the inspection but had indications of previous flow appearing to be originating out of the oil-shale outcrop. The company is monitoring the flow and water chemistry of the seep. Request that the location of this seep be added to the hydrology map.

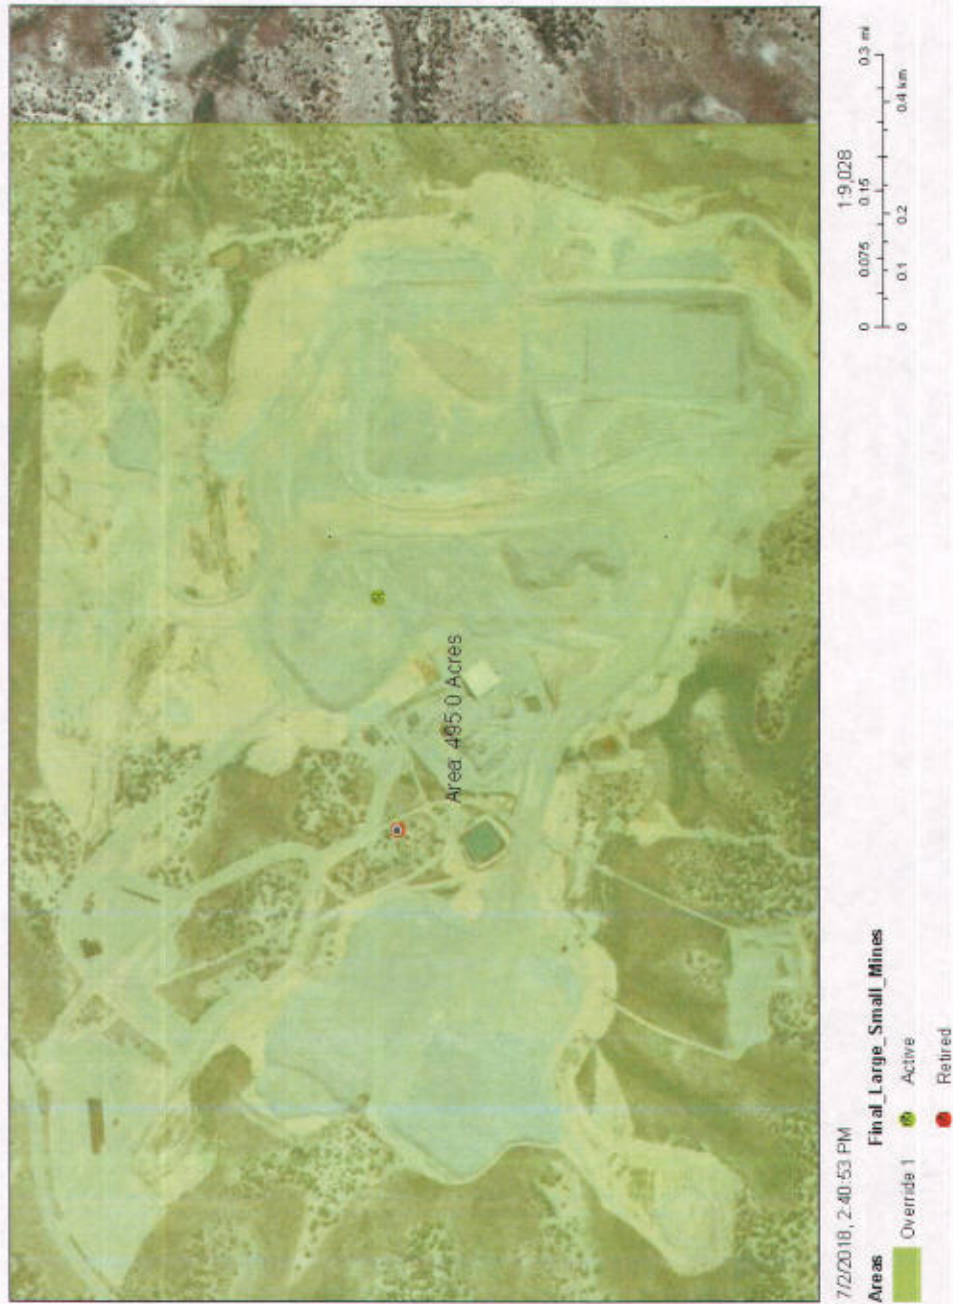
Current Disturbance Area approximation

Elements of Inspection	Evaluated & Commented	Enforcement
1. <i>Permits, Revisions, Transfer, Bonds</i>	<input checked="" type="checkbox"/>	<input type="checkbox"/>
Discussed the status of the mine. The company is primarily working in the laboratory to develop new test capsule technology. Research is at least 2 years out until field scale testing is viable. The NOI was recently amended to include a new water impoundment structure adjacent to the Pilot area. An updated EPS Facility Site Plan (Figure 1A) was also submitted. The total disturbance area current measures at just under 500 acres. The mine is permitted for 16,838.
